Veritas Appliance

Hardware Service Procedure

Operating System Disk Drive Replacement: NetBackup 5030/5230 Appliance

Document Number: 124

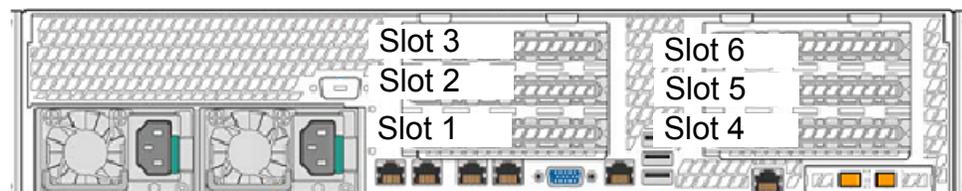
Figure 2 Rear view of the NetBackup 5030 Appliances

The NetBackup 5030 Appliance is a 2U system with no internal storage. It relies on a single, 3U Veritas Storage Shelf, which is connected to an external storage RAID controller on the back panel of the appliance. From the front panel of the NetBackup 5030, you can view 12 disk slots, arranged horizontally. Two SAS disks are installed in slots 0 and 1. The remaining slots hold blank carriers. A small control panel is on the right side of the front panel. It contains system LEDs and operations buttons, including the power button. The power sockets are on the left side of the rear panel. The rear panel contains six PCIe slots. Slot 1 in the PCIe riser 2 holds the external storage RAID controller that is used to connect the appliance to the storage shelf.

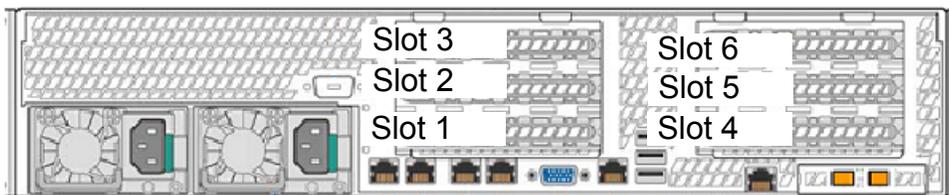
Figure 4 Rear view of the NetBackup 5230 Appliances

The power sockets are on the left side of the rear panel. The rear panel contains six PCIe slots. Slot 1 is used for the external storage RAID controller if the appliance is connected to a storage shelf. The remaining slots may hold 10 Gb Ethernet NICs or Fibre Channel HBAs, depending on the configuration. An internal storage RAID controller is installed on the mainboard of the appliance.

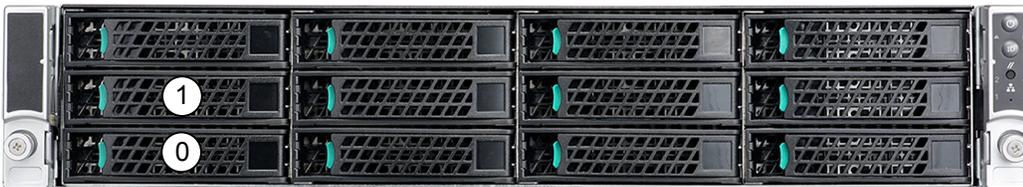
Figure 5 NetBackup 5030/5230 Appliance operating system disk drive slot locations

This section describes how to replace the 1-TB operating system disk drives in the NetBackup 5030 and 5230 appliances. The two 1-TB disk drives located in Slots 0 and 1 contain the operating system for the appliance. Both drives are mirrored.

Caution: Only 1-TB drives can be used in slots 0 and 1. Make sure you do not replace the faulty drive with any other size drive.

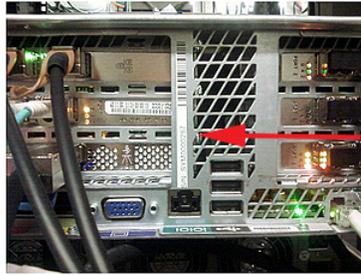
- 1 Verify the appliance serial number. The serial number begins with the letters SYM or VTAS, and is located on a label on the rear panel of the appliance.

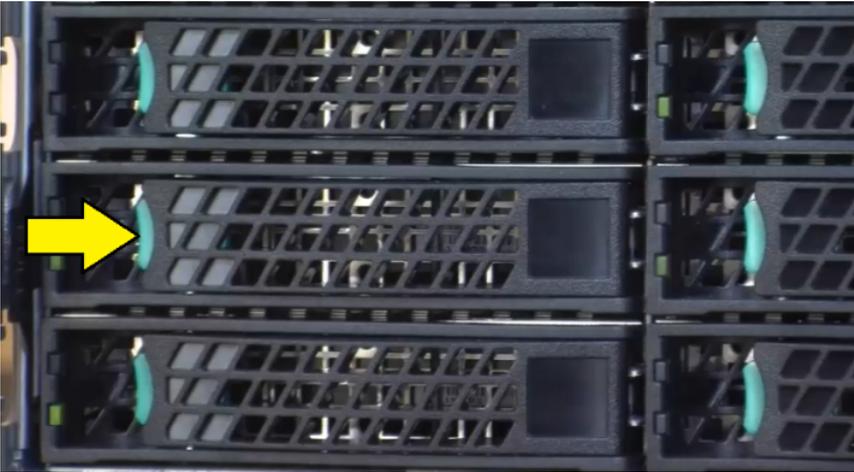
- 4 Press the green button on the left side of the drive to release the disk drive lever.

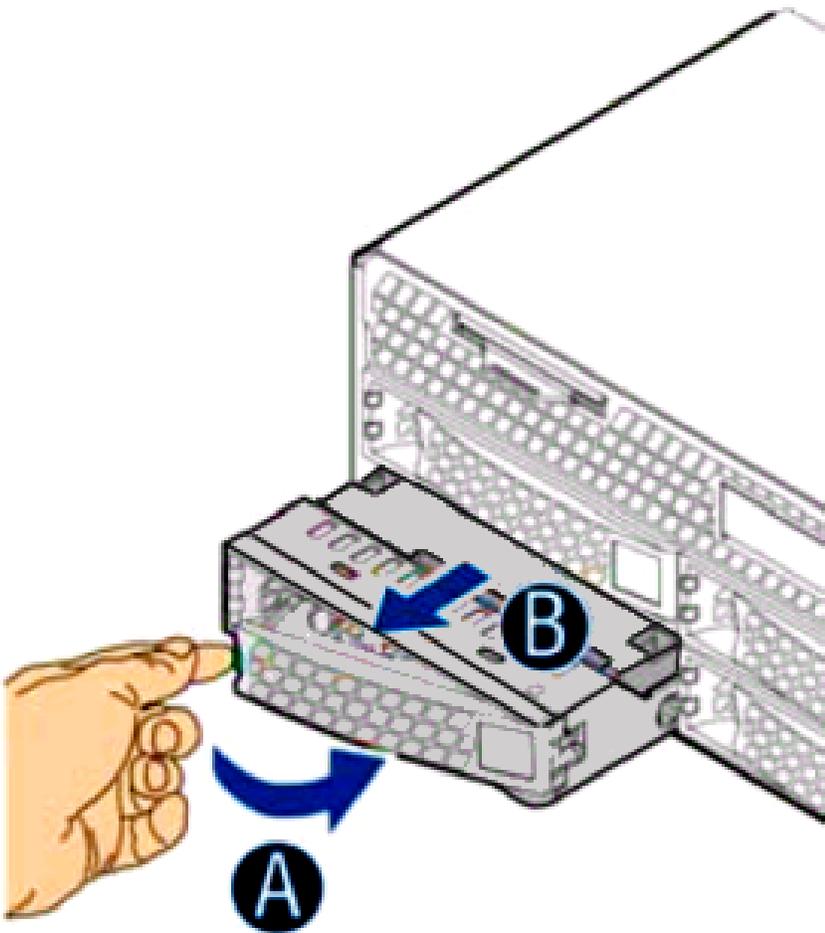
- 5 Pull the lever open completely but do not slide the drive out of the slot. Let the drive motor stop spinning. This takes about 30 seconds.
- 6 Slide the drive out of the slot.
