Veritas Appliance

Hardware Service Procedure

Storage Disk Drive Replacement: NetBackup 5230/5240 Appliance

Document Number: 108

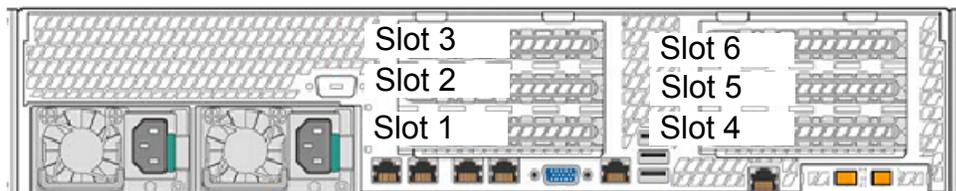
Figure 2 Rear view of the NetBackup 5230 Appliances

The power sockets are on the left side of the rear panel. The rear panel contains six PCIe slots. Slot 1 is used for the external storage RAID controller if the appliance is connected to a storage shelf. The remaining slots may hold 10 Gb Ethernet NICs or Fibre Channel HBAs, depending on the configuration. An internal storage RAID controller is installed on the mainboard of the appliance.

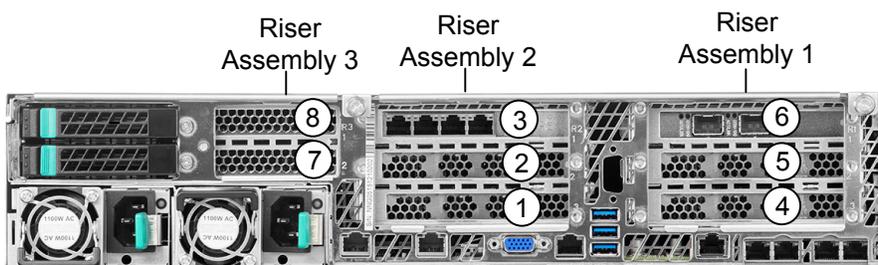
Figure 4 Rear view of the NetBackup 5240 Appliance

SAS-3 cables are used to connect the NetBackup 5240 Appliance to the storage shelves. SAS-3 cables are also used to connect the storage shelves to each other.

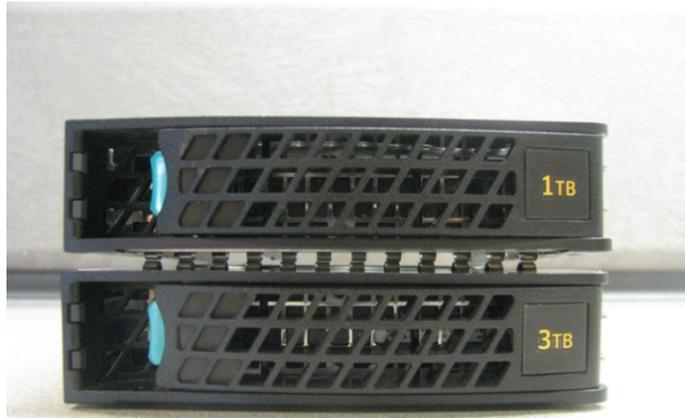
For NetBackup 5230 Appliance, only replace 1TB drives with 1TB drives and 3TB drives with 3TB drives. If a drive does not have a label, it is 1TB in size. The picture below shows how the drives are labeled.

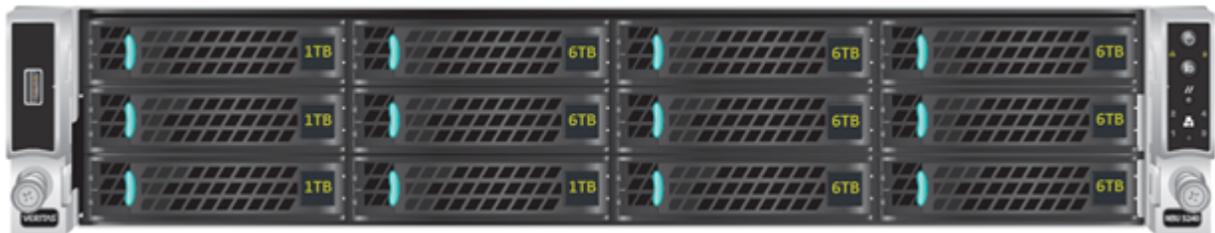
For NetBackup 5240 Appliance, only replace 1TB drives with 1TB drives, 3TB drives with 3TB drives, and 6TB drives with 6TB drives. If a drive does not have a label, it is 1TB in size. The picture below shows how the drives are labeled.

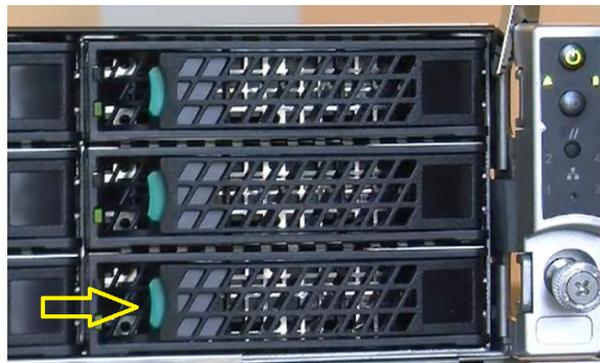
- 4 Press the green button on the left side of the drive carrier to release the disk drive lever.

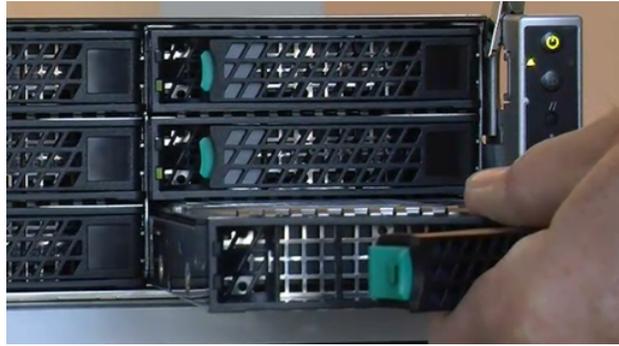
- 5 Pull the lever open completely but do not slide the drive out of the slot. Let the drive motor stop spinning. This takes about 30 seconds.
- 6 Slide the disk drive and its carrier out of the slot.

Caution: You must complete the hard disk drive swap within three minutes. Leaving the disk drive slot open for longer than three minutes can result in the appliance overheating and cause other components to fail.

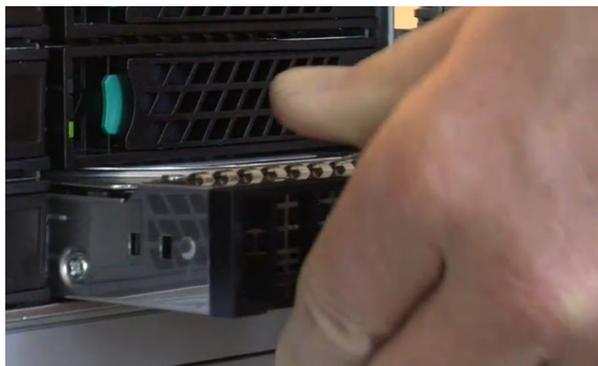
- 2 Remove the replacement disk drive from the ESD-protective wrapper.
- 3 Press the green button on the drive carrier to release the lever.
- 4 Pull the lever open completely.
- 5 Slide the disk drive and its carrier completely into the slot.

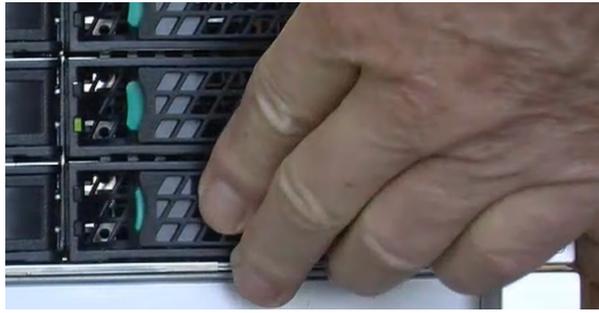
- 6 Close the lever and make sure that the disk drive cover is flush with the front panel.

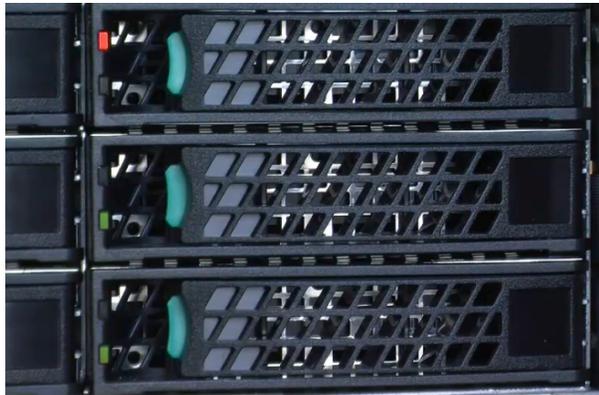
- 7 Check the status of the LEDs on the drive that you replaced. The drive activity LED turns green when the connection is good.

After a short period, the drive status LED will start blinking amber to indicate that the rebuild is in progress.
