Veritas Appliance

Hardware Service Procedure

Replacing a disk drive carrier in a Veritas 5U84 Storage Shelf

Document Number: 210

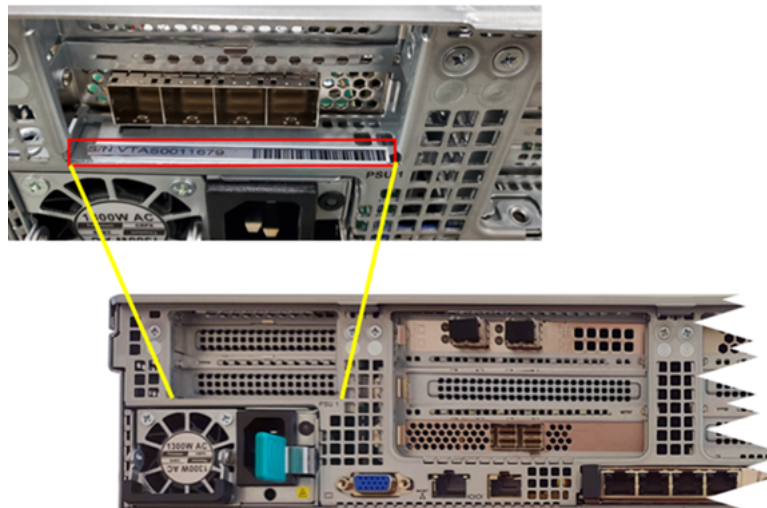
- For the 3360/5360 Appliance, the serial number is located on the rear panel of the appliance above PSU 1 and begins with letters VTAS.

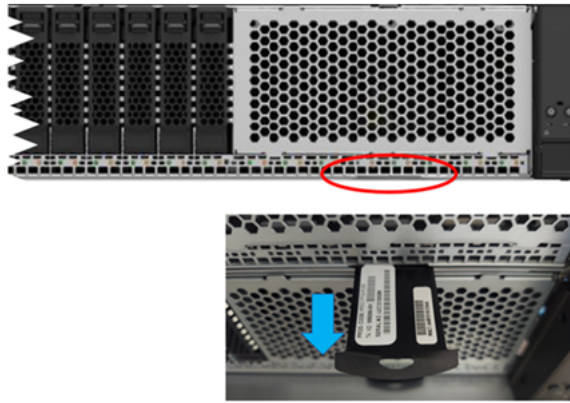
The serial number can also be found on the pull-out tab on the front of the appliance.

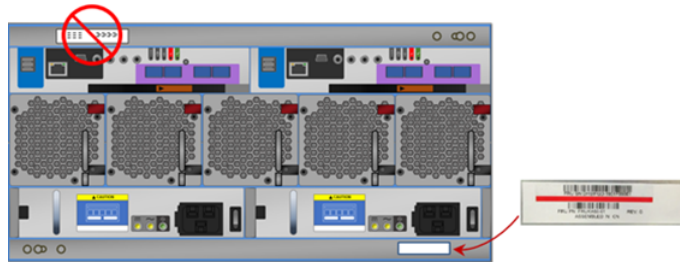
If the work order provides the 5U84 Storage Shelf serial number, verify that the serial number on the work order matches the serial number on the storage shelf. The Veritas Serial Number label is located in the lower right-hand corner of the shelf's rear panel under the power supply. Do not use the label in the upper left-hand corner for the Veritas Serial Number.

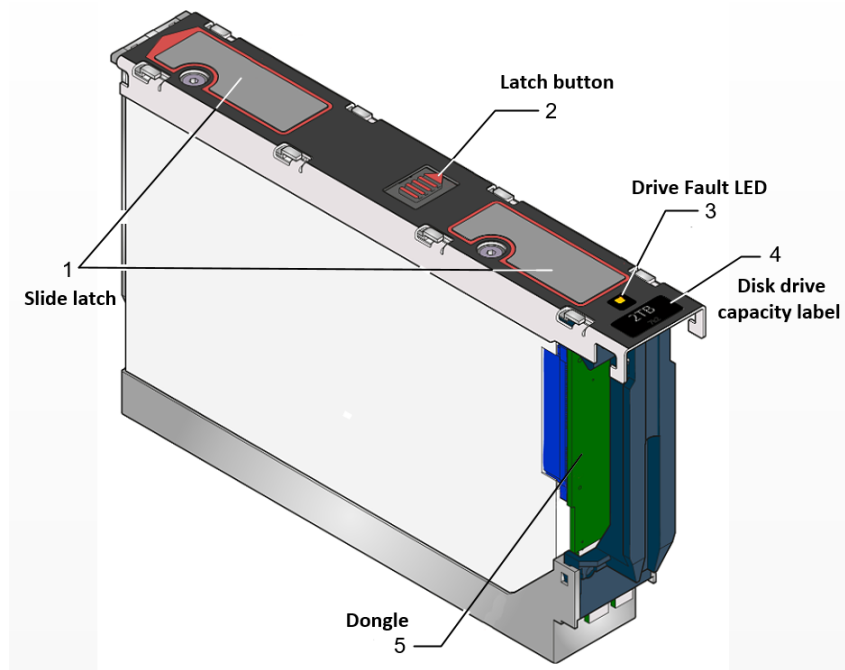
If the drive has failed, the drive fault LED will be lit amber on the relevant drawer.

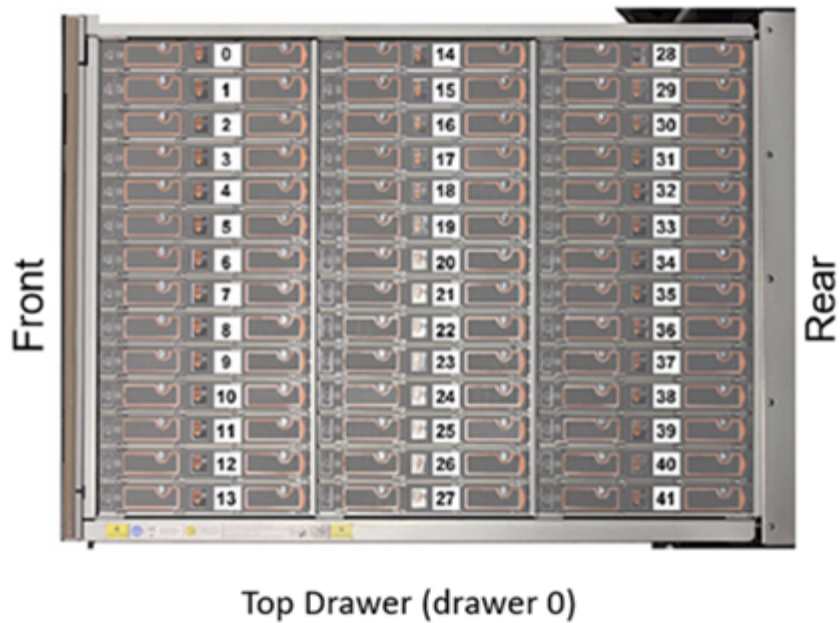
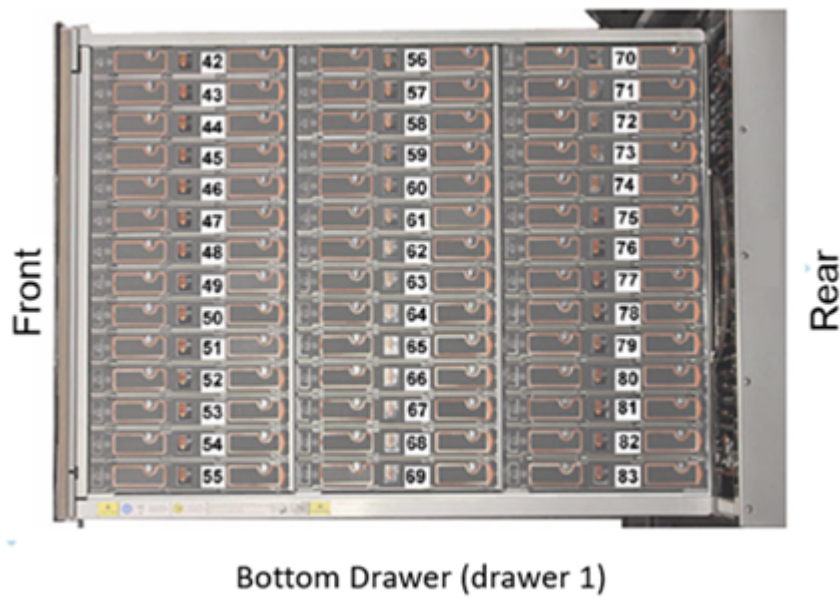
If the drive number is known, the drive location mapping can be used.

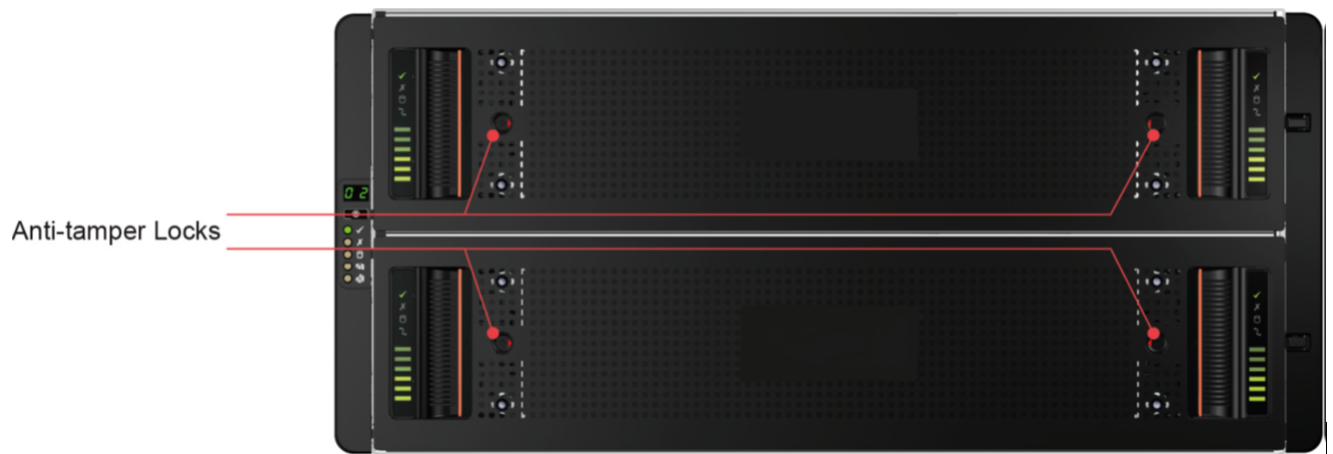
Make sure the drawer anti-tamper locks are not engaged. The red arrows on the locks point inwards if the locks are disengaged.

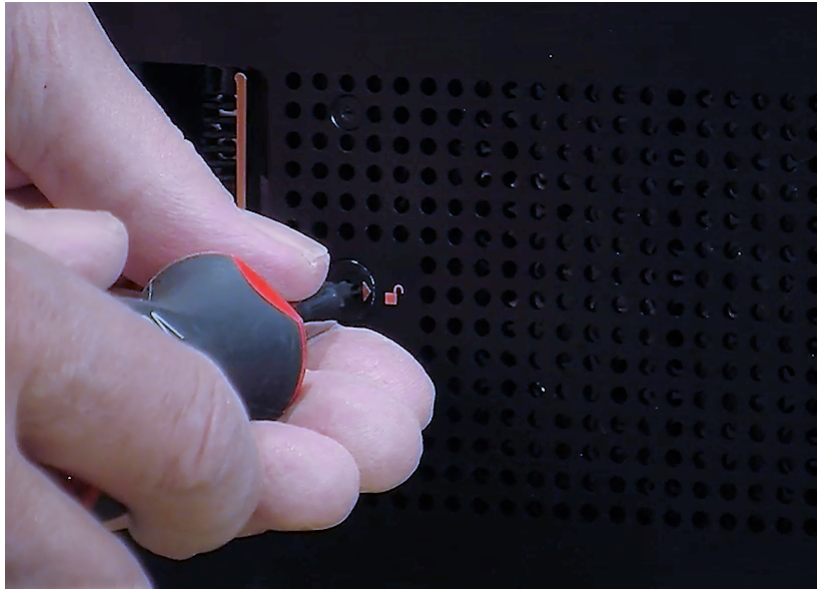
Unlock them if necessary by rotating them counterclockwise using a screwdriver with a Torx T20 bit.

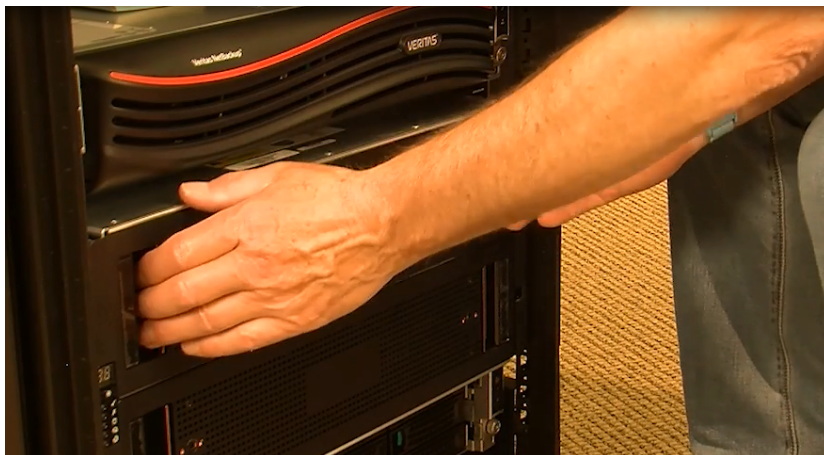
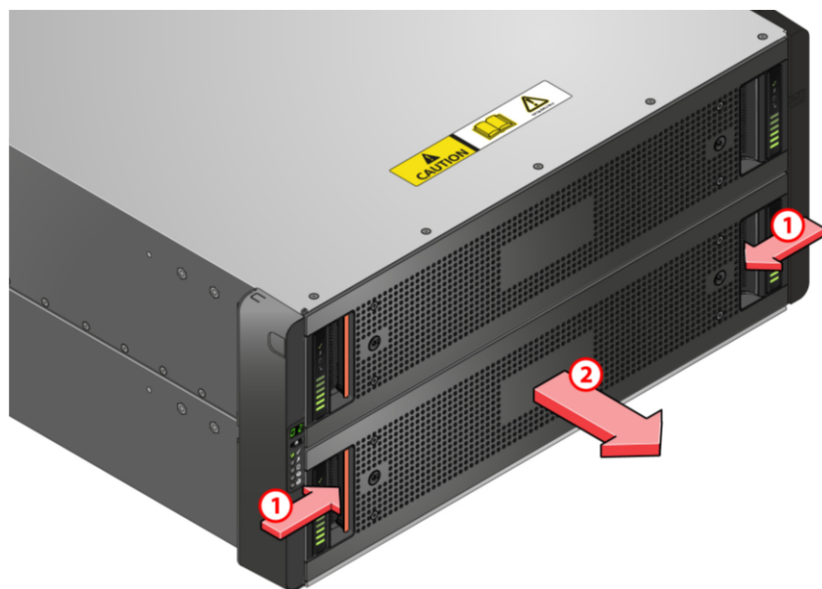
- 3 Push the drawer latches inward and hold them.

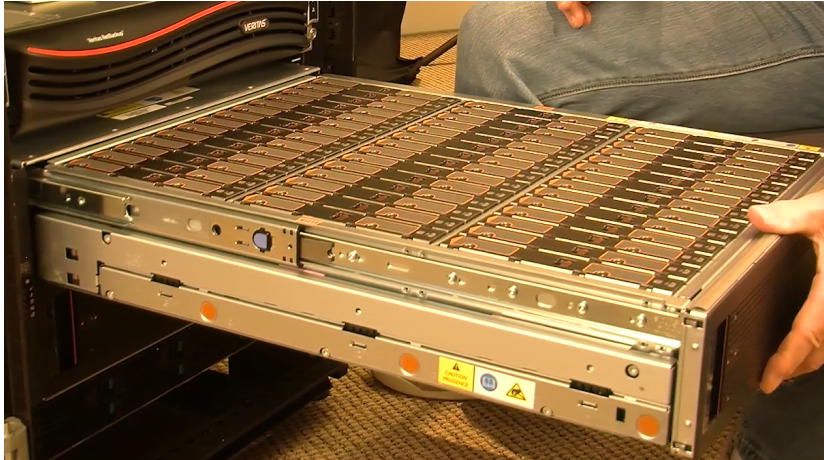
- 4 Pull the drawer all the way out until it locks open.

Caution: The drawer must not be left open for more than two minutes while the enclosure is powered.

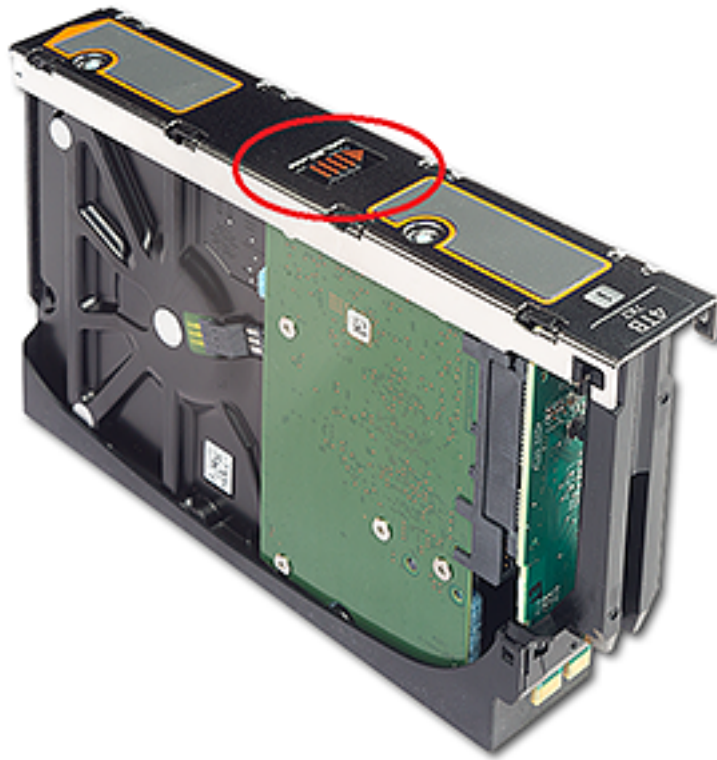
- 6 Slide the release button and the disk drive carrier pops up slightly from the slot.

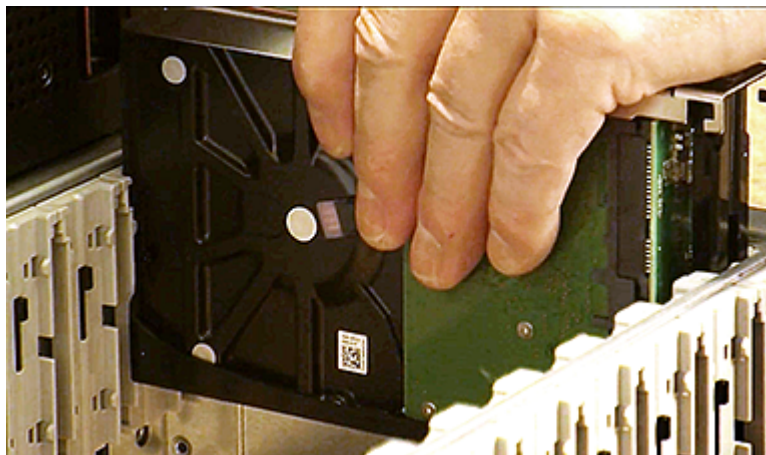
- 7 Lift the drive out of the slot approximately 1 inch (25mm), and then wait 30 seconds, allowing the drive to spin down.

Caution: Damage can occur to a drive if it is removed while it is still spinning. Make sure that the drive has stopped prior to removal. Swap one drive at a time only. Removing more than one drive at one time can affect system functionality.

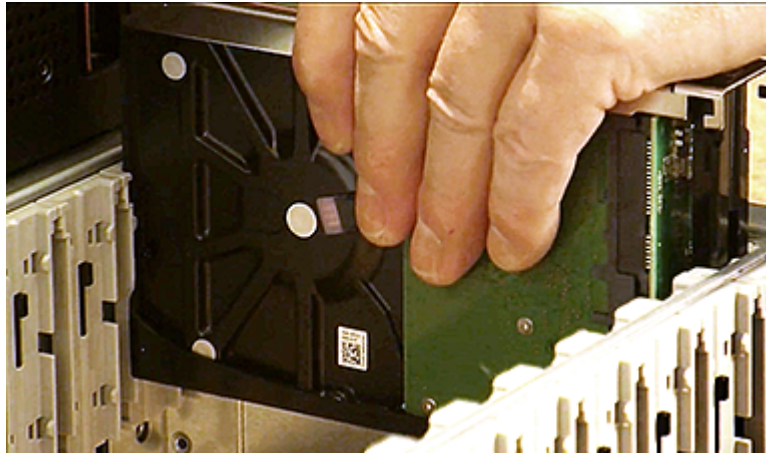
- 2 Lower the replacement new disk drive carrier into the slot, with the drive capacity label facing towards you.

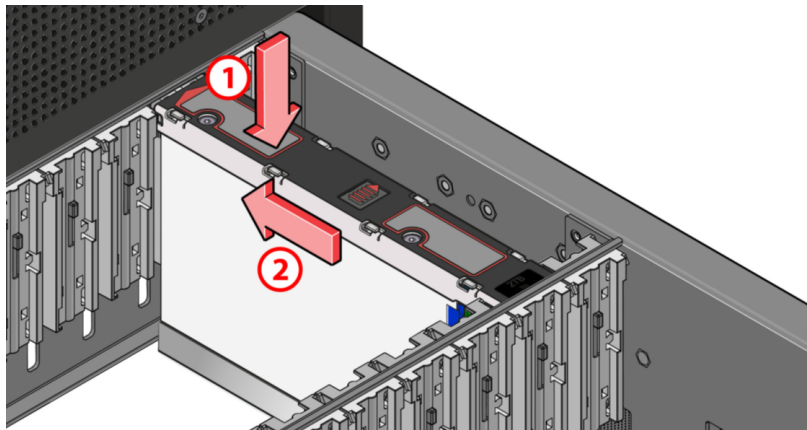
- 3 Push the drive downwards and hold it down while sliding the drive carrier plate. This locks the drive in place.

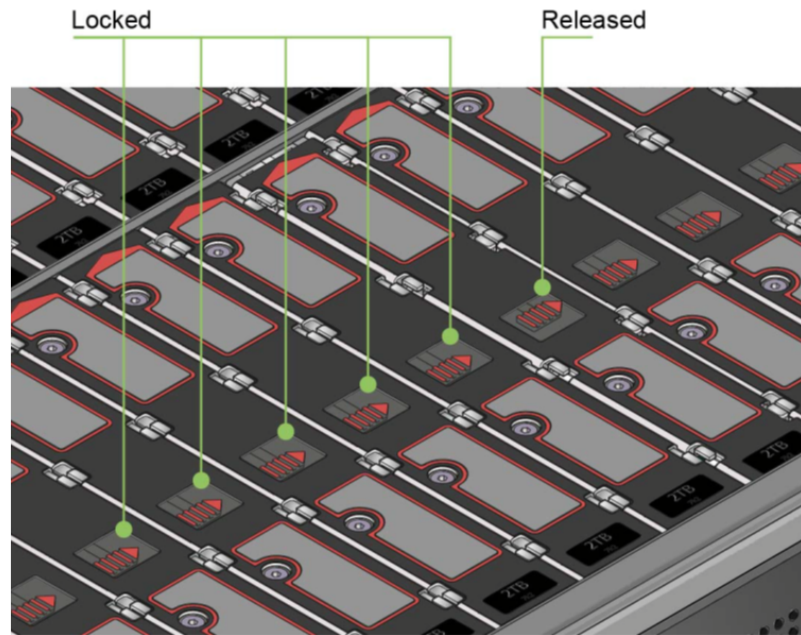
- 4 Check that the release latch has returned to its locked position.

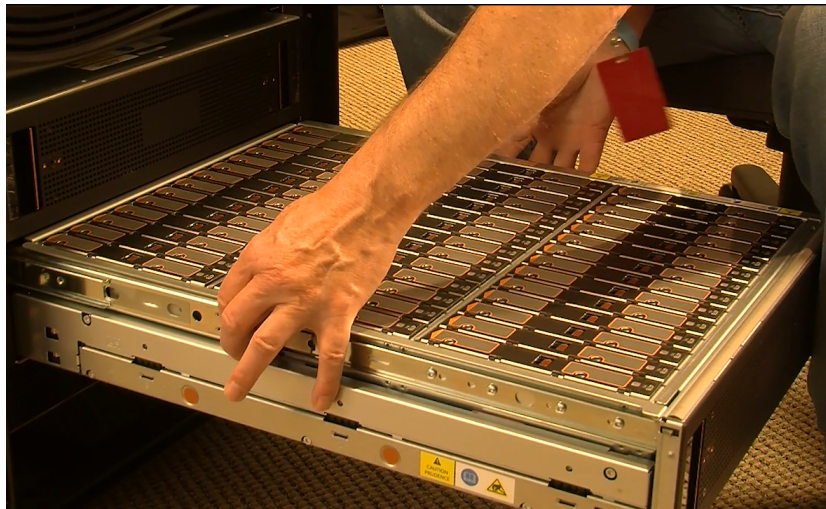
- 5 Close the drawer by pressing and holding both latches located on the sides of the drawer.

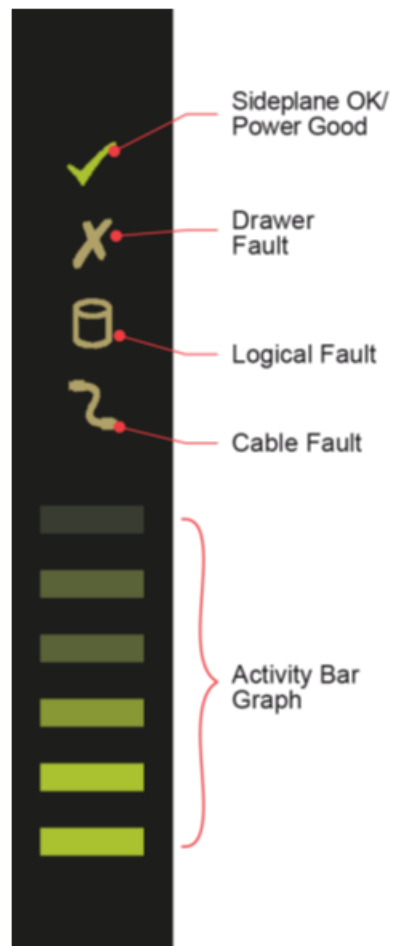
- 6 Push the drawer all the way back into the enclosure, making sure it clicks home.
- 7 Lock the drawer by turning both anti-tamper locks clockwise using a screwdriver with the screwdriver with a Torx T20 bit.
- 8 Check the status of the drawer LEDs for any faults that may be present.

9 If faults appear, contact Veritas Technical Support.
