Veritas Appliance

Hardware Service Procedure

NetBackup 5330 Appliance Compute Node Disk Drive Replacement

Document Number: 139

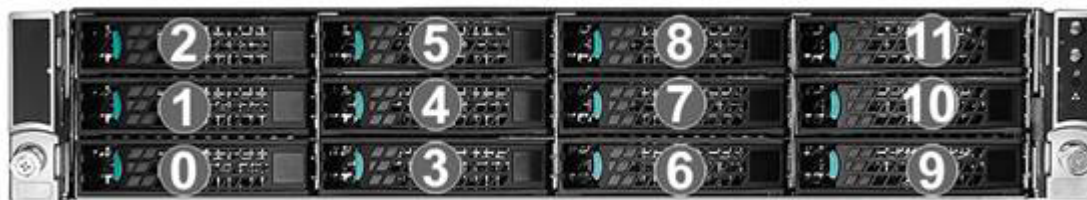
A small control panel is on the right side of the front panel. It contains system LEDs and operations buttons, including the power button.

Figure 1 Front view of the NetBackup 5330 Appliance compute node

The NetBackup 5330 Appliance compute node contains eight 3TB SAS disks, which can be accessed from the front panel. An embedded RAID controller on the compute node's mainboard is used to configure six of the eight disks into two RAID1 mirrored volumes, plus two hot-spare disks. These volumes are labeled Volume 0 and Volume 1. If a disk in either RAID volume experiences a hardware error, the appliance automatically initiates a RAID rebuild operation. During the rebuild operation, the appliance randomly selects a hot-spare disk, and then rebuilds the RAID volume.

The disks in slot 6 and slot 7 are reserved for future use, while the slots 8 through 11 are empty.

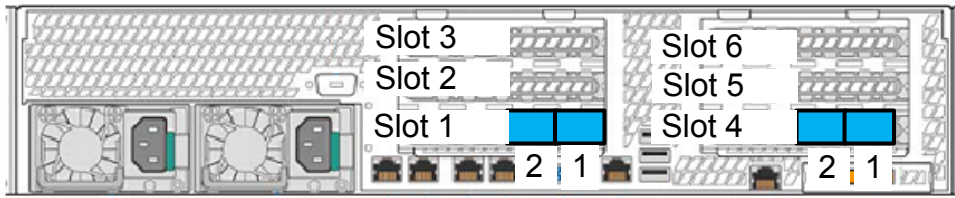
Figure 2

The rear panel contains six PCIe slots. The slots may hold 10 Gb Ethernet NICs or 8 Gb Fibre Channel HBAs. Power sockets are on the left side of the rear panel.

Rear view of the NetBackup 5330 Appliance compute node

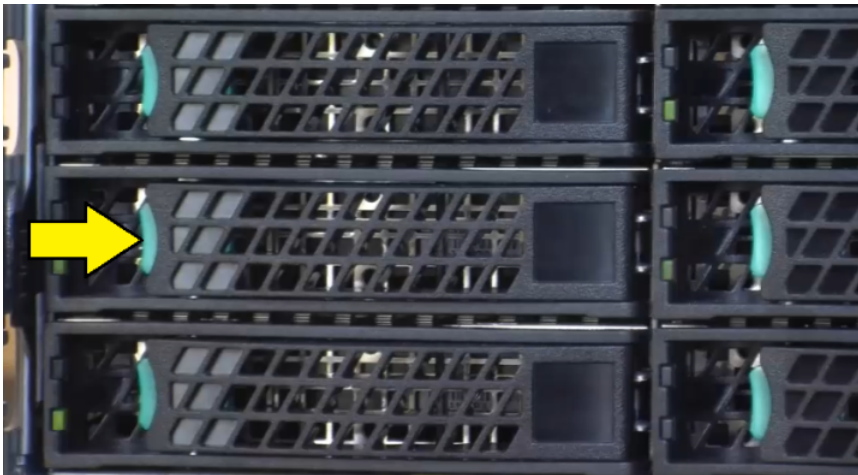
- 3 Locate the drive that you want to replace. The drive must be in Slot 0-7, and the drive status LED should be solid amber. The drive slots are shown in the figure below.

- 4 Press the green button on the left side of the drive to release the disk drive lever.

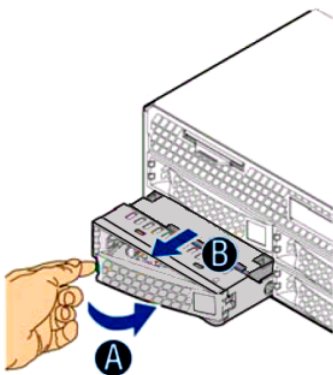
- 5 Pull the lever open completely but do not slide the drive out of the slot. Let the drive motor stop spinning. This takes about 30 seconds.
- 6 Slide the drive out of the slot.
